Full-field Deformation Measurement Techniques for a Rotating Composite Shaft

Lee W. Kohlman¹, Charles R. Ruggeri¹,
Richard E. Martin², Gary D. Roberts¹,
Robert F. Handschuh¹

¹NASA Glenn Research Center

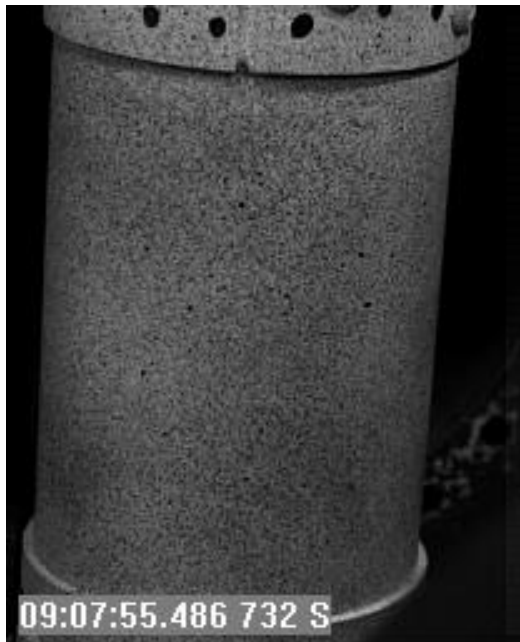
Videos of Impacts
(recorded at 25,000 fps, played at 25 fps)

Two low speed impacts were performed using a 1/4" steel ball bearing to induce delamination in the composite tube.

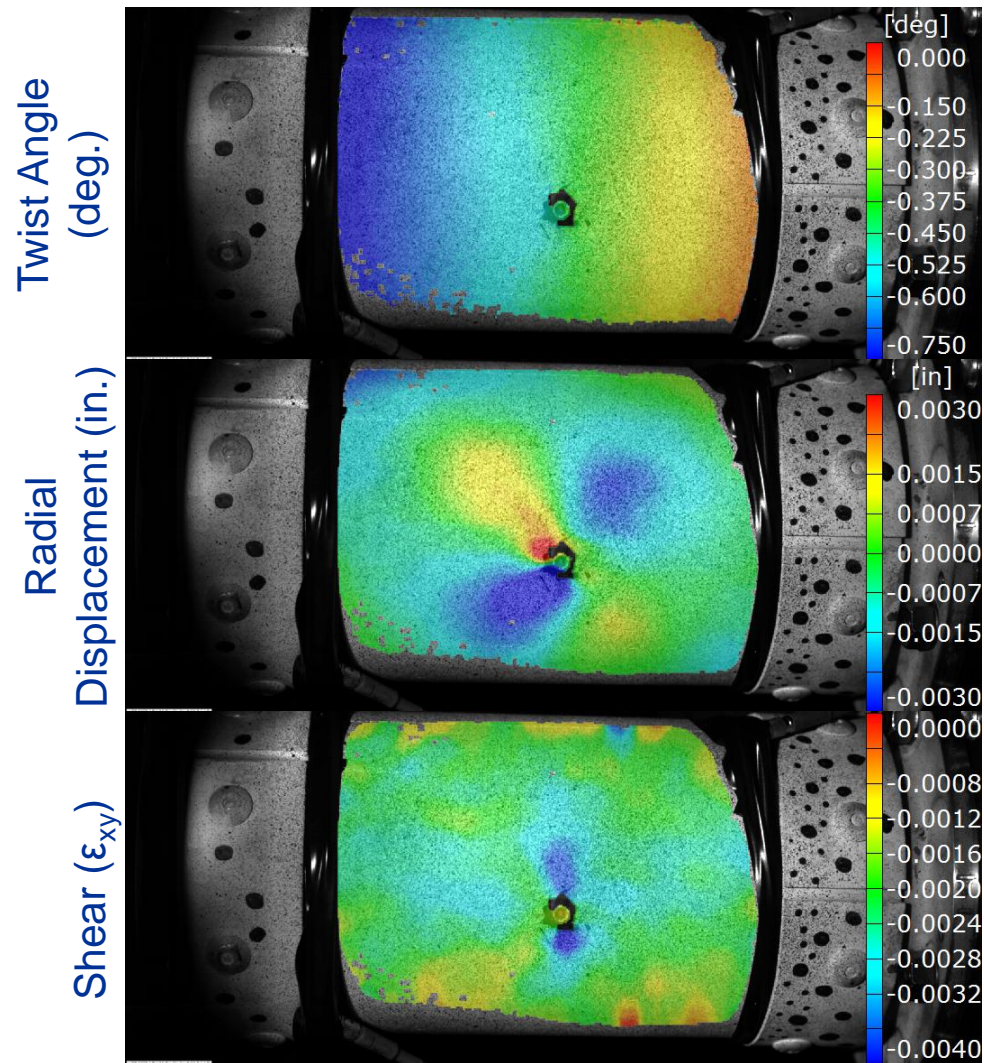
DIC Results: Static, Damaged @ Max Torque (~38,000 in-lbs)

The tube failure initiated at the impact damage location on the back of the tube.
